Subj: BRANCH MEDICAL/DENTAL CLINIC, QUANTICO POE REPORT

POST OCCUPANCY EVALUATION REPORT

BRANCH MEDICAL/DENTAL CLINIC QUANTICO, VIRGINIA

PREPARED BY: NAVFACHQ MEDICAL FACILITIES DESIGN OFFICE

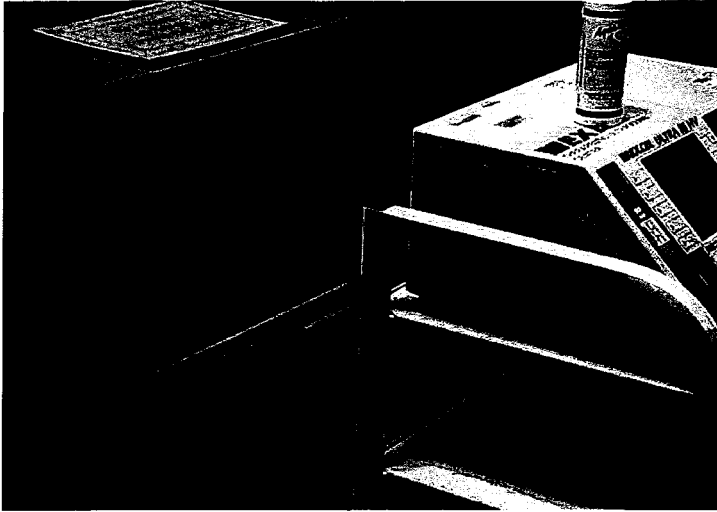
Picture 2

1. Makeshift hot pack area was needed; ice machine is not used. Electric stimulator in front of ice machine. *Physical Therapy - Green Team*

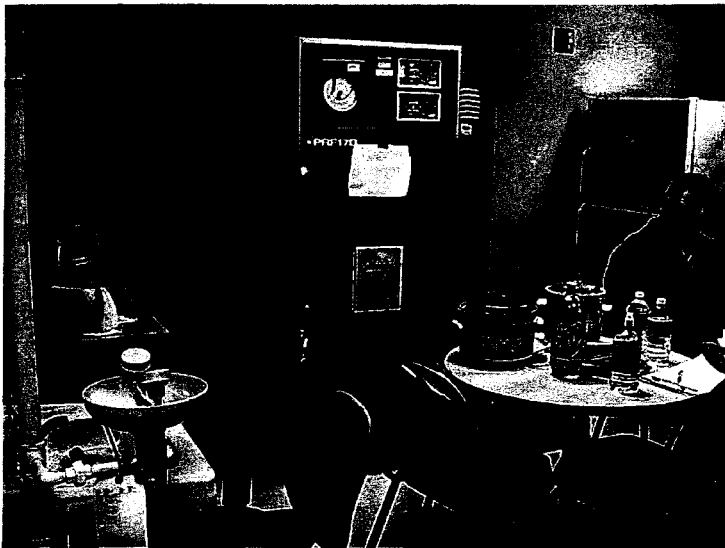
Picture 3

2. Stocking space is insufficient. Staff lounges too small, used for storage. *Pharmacy - Green Team*

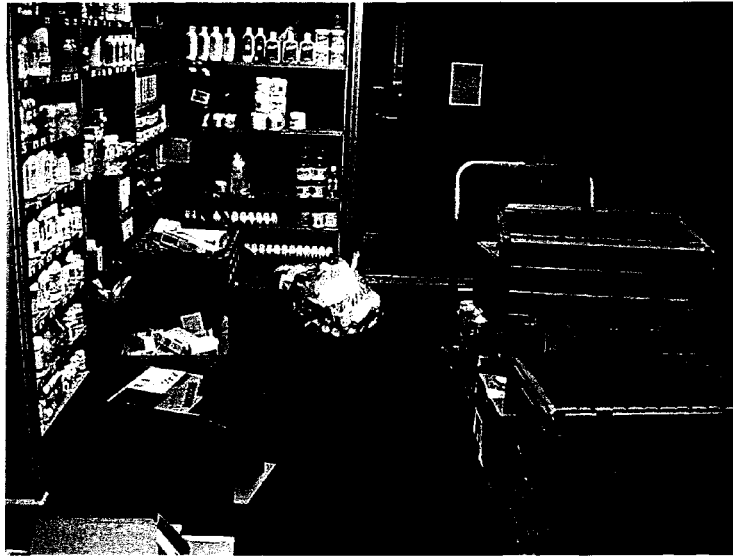
Picture 4

3. Supply space and admin space needed. *Pharmacy - Green Team*

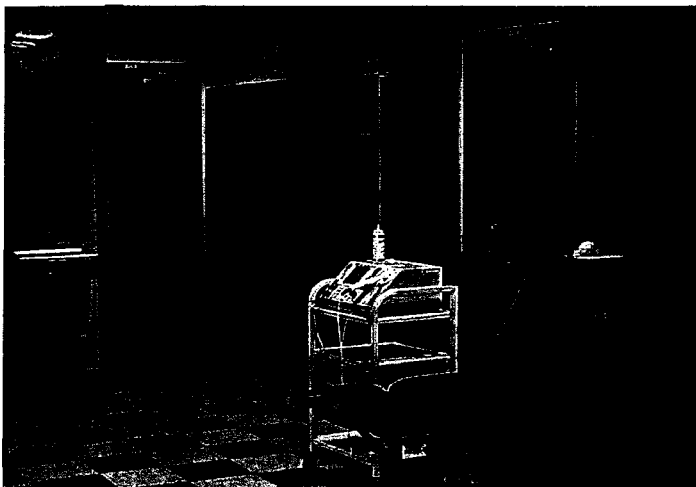
Picture 5

21. No storage area dedicated—Shelving located in treatment area. *Physical Therapy - Green Team*

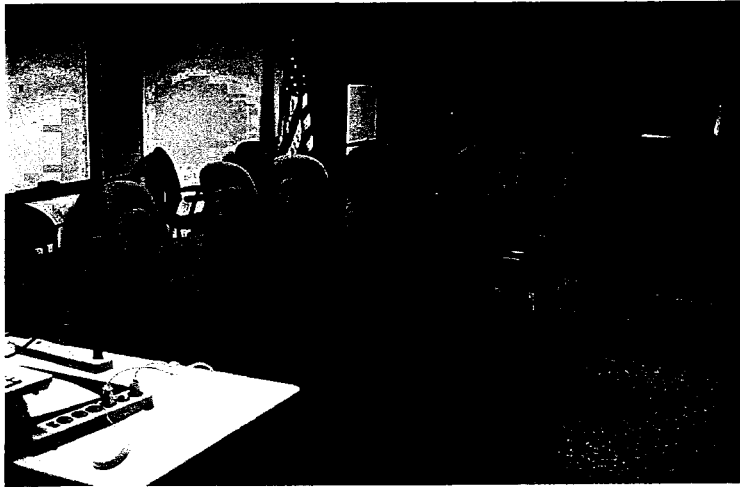
Picture 6

25. CO's conference room functions well and sized adequately. Labor union required secretaries to have separate offices. Bullpen seating was undersized. Also, the area is compromised with back door circulation to mailroom. *Command Suite, Administration - Green Team*

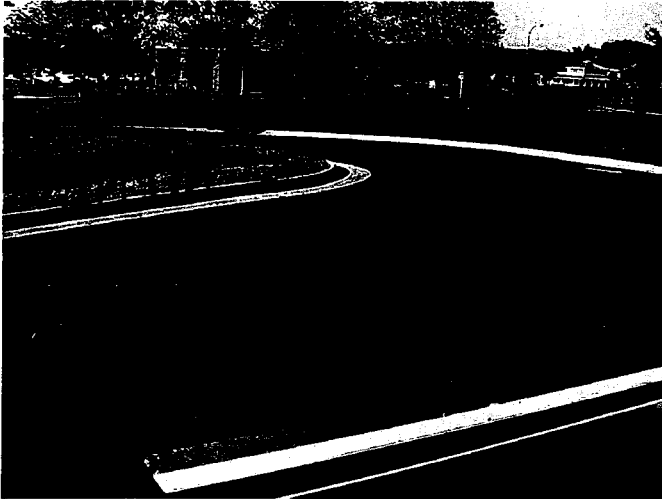
Picture 15

4. Turning radius at drive-up window is said to be tight, but I believe it is ok. *Pharmacy, Civil and Landscaping - Green Team*

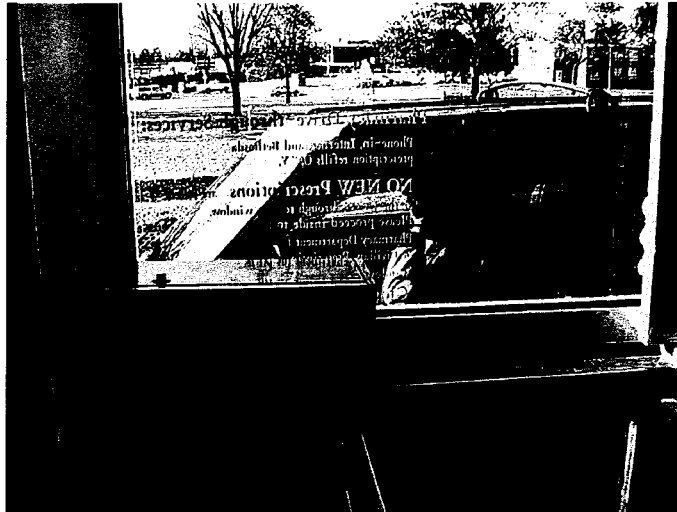
Picture 17

8. Pharmacy drive-thru is difficult because of drivers pulling up and being too far away. Reach points for patients can be great. Communication system needed to be added to talk between pharmacy and drive-up patient. Having a way to get patient out of driveway queue is important for patient who has no business being in line. Height. *Exterior, Pharmacy Drive-Thru - Gold Team*

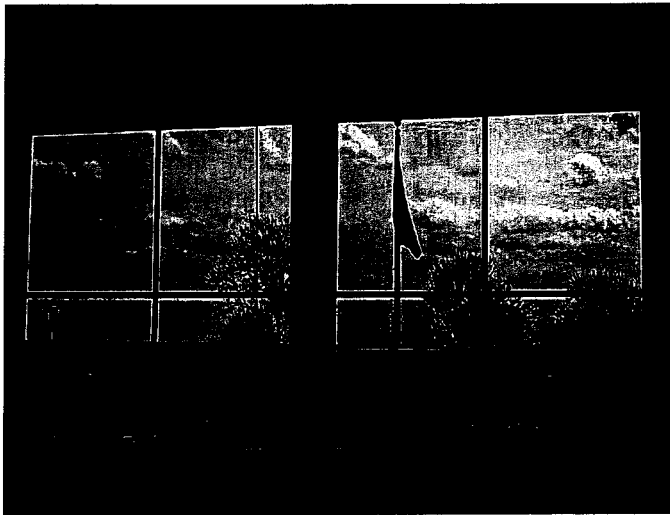
Picture 18

9. Who specified or accepted the flagpole? It is not the type the user desired. *Exterior, Flag Pole - Blue Team*

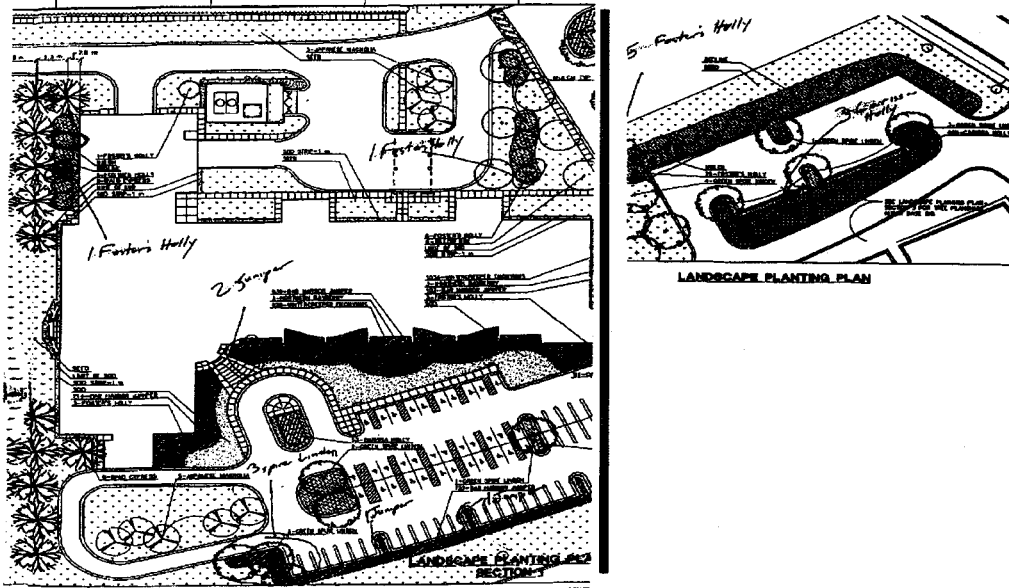
Picture 19

13. Attached is a drawing showing the location of plants and trees that have died and need to be replaced. *Exterior, Landscaping - Blue Team*

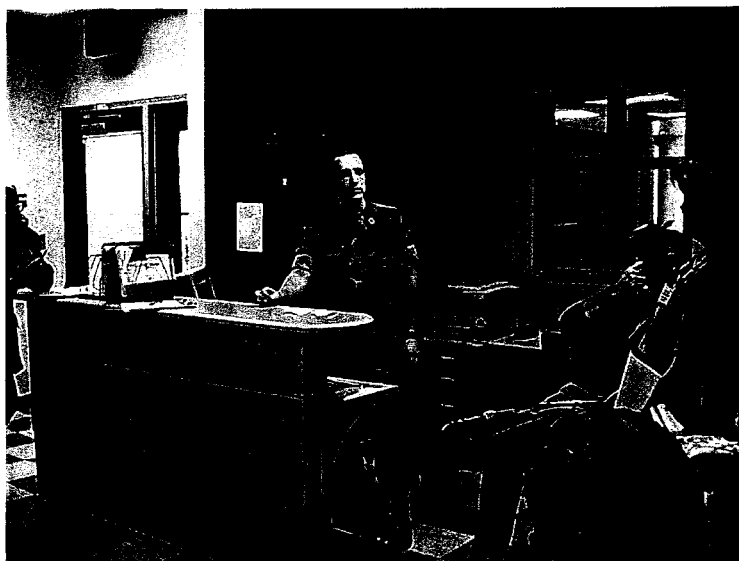
Picture 23

28. Check-in area is inside PT clinic vs. at a typical check-in window or counter near PT waiting area. (This appears to have been a result of a change order.)
Physical Therapy, Check-in Area - Green Team

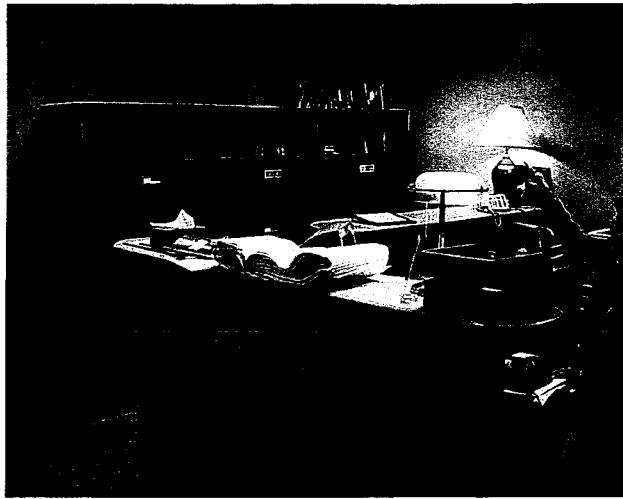
Picture 26

64. Staff not happy with position of the check-in counter. *Mental Health, Reception Desk - Green Team*

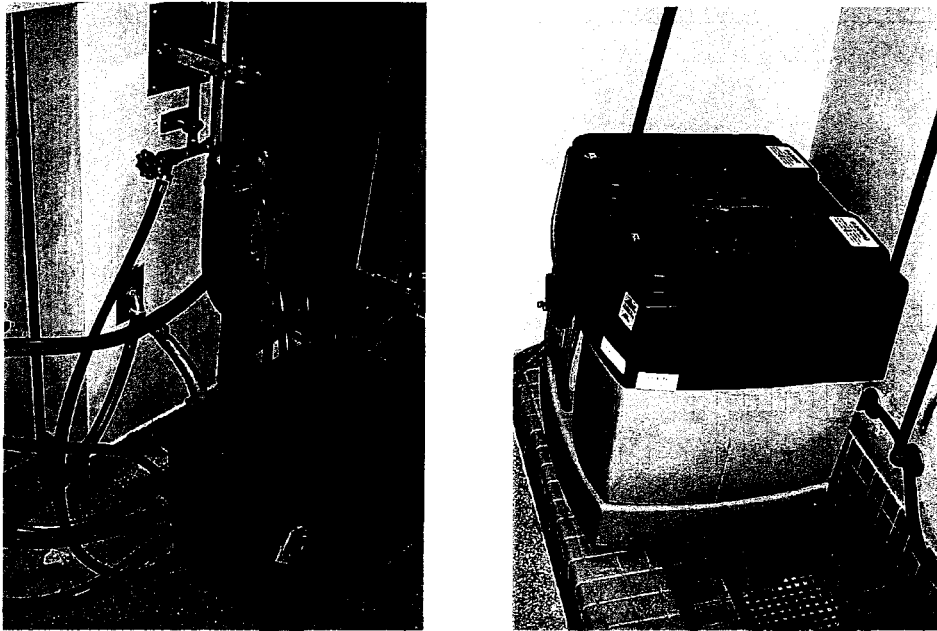
Picture27

71. Counter top that supports the developer (AT-2000) should be deep enough to allow the equipment to sit correctly on the surface facing the user. Per agreement between dental and medical, medical processes the waste from the processor and therefore there is no silver recovery unit here. *Dental, Darkroom 2A23 - Blue Team*
72. Mop basin not sufficiently sized for mixing units; also no room to place silver recovery in mop basin. User would like to place basin below silver recovery unit. *Radiology, Darkroom 1F01 - Gold Team*

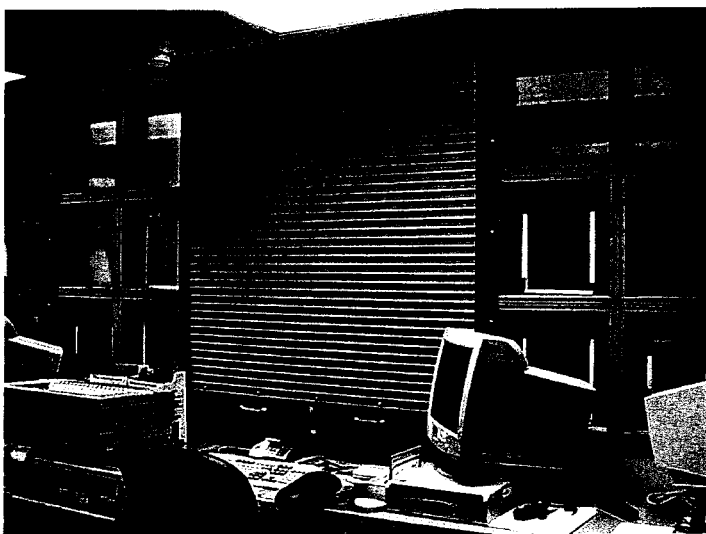
Picture 29

78. Manual pull down hard to maneuver, should drop in a fire but have to reset by company. (Suggest-electronic reset after fire alarm clear) (Hard pull up and down) Scratches due to use of pole that you have to use. *Records, Pull Down Shutters - Gold Team*

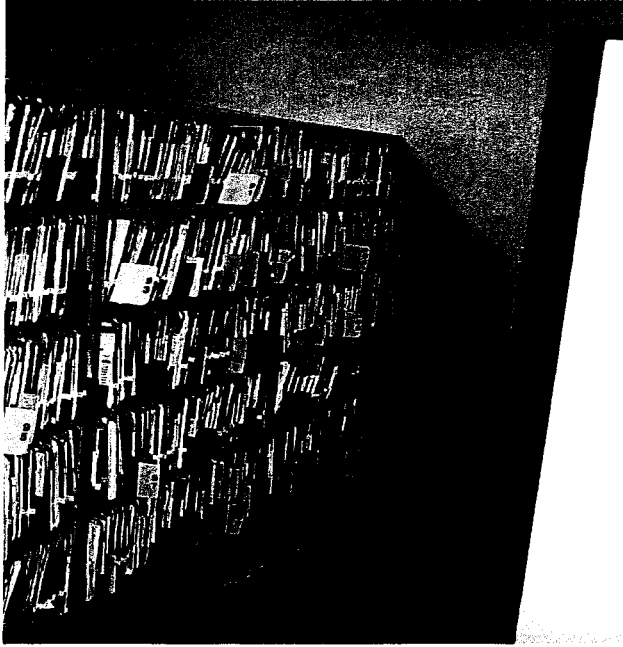
Picture 30

79. Records/files old--have to get on floor to pull records; cost cut issue. Decentralize records to go to clinics. Modular workstations work well. Need pad under carpet. *Records - Gold Team*

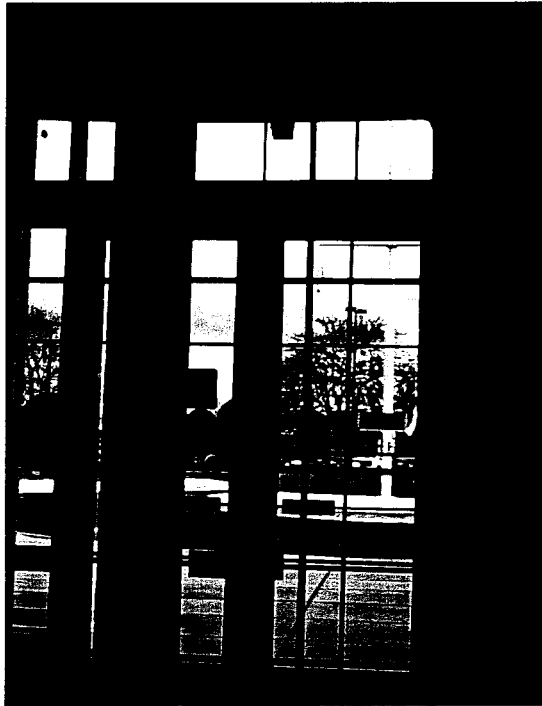
Picture 37

145. Vestibule doors--not enough space between doors and so when they open the information desk gets all the cold air coming in. Also need receptacles at work desk. *General, Information Desk - Gold Team*

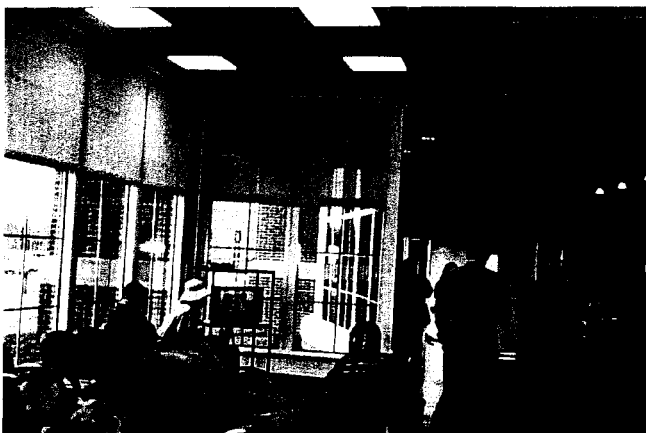
Picture 42

189. Interior curtains very nice but expensive. Complaints about 1-1/2 hours of sunrise in eyes of receptionists. *Immunizations, General - Gold Team*

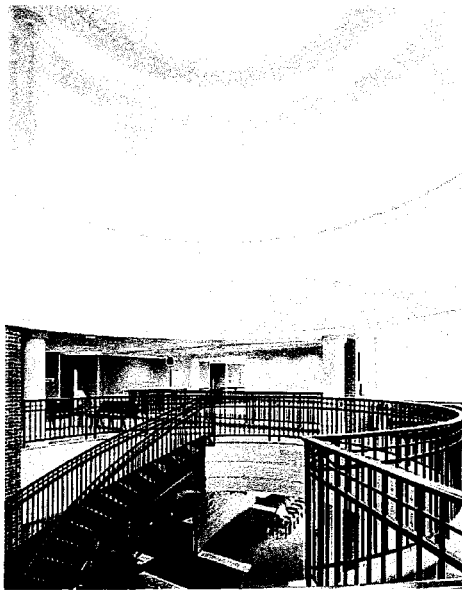
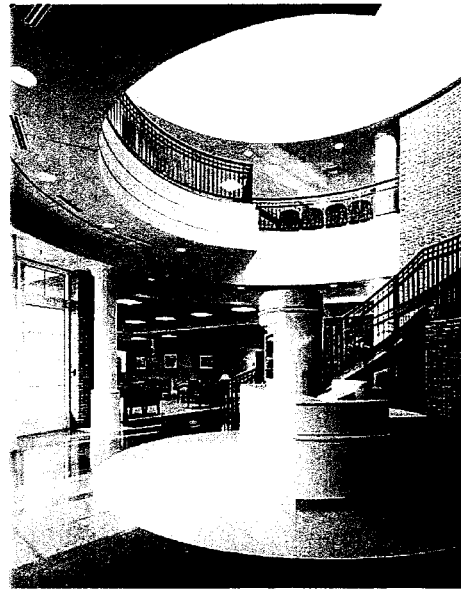
Picture 44

197. Some complaints concerning noise transmission. Suggest gaskets around the door and insulation in the wall. Also suggest insuring that the walls extend above the ceiling in more areas. *Pediatrics, Exam Room 1G19 - Gold Team*
198. Window size--Patient privacy issue. 1) Barrier for sound. 2) Move waiting area further back from window. *Pharmacy - Green Team*
199. Clinic had to procure their own partition to separate the two cubes. This reduces the noise from screaming. *Immunizations, General - Gold Team*
200. Privacy/Noise issue at balcony above reception areas below. *General, Lobby - Blue Team*

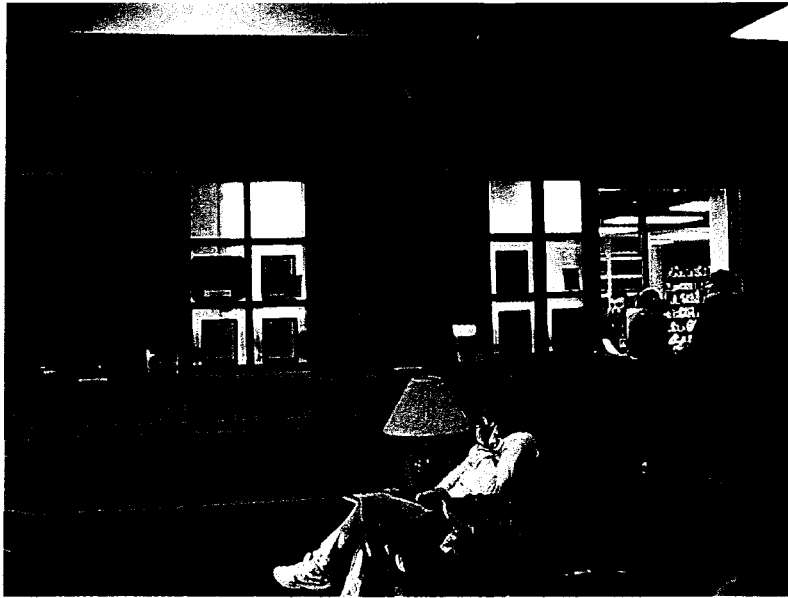
Picture 46

209. Pharmacy "number" for patient system installed but as a second thought.
Pharmacy - Green Team

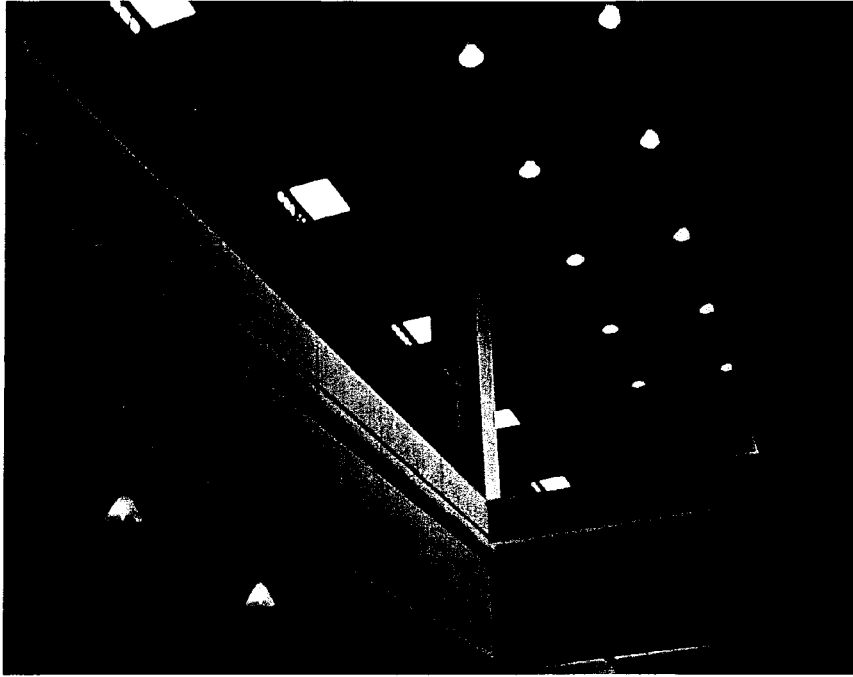
Picture 52

67. Canned lighting in high ceiling above reception desks is difficult to change.
Users may have to get a cherry picker to change the light bulbs. *Lobby, Waiting
Areas - Blue Team*
